October 28th, 2008

Post Inspection Clearance Assessment Report
Department of General Services
LaCroix Davis Investigative Areas – 22nd Floor
Board of Equalization Building, 450 N. Street
Sacramento, California

October 13th and 20th, 2008
BOE 22nd Floor LCD Containment Clearances
Sacramento, CA

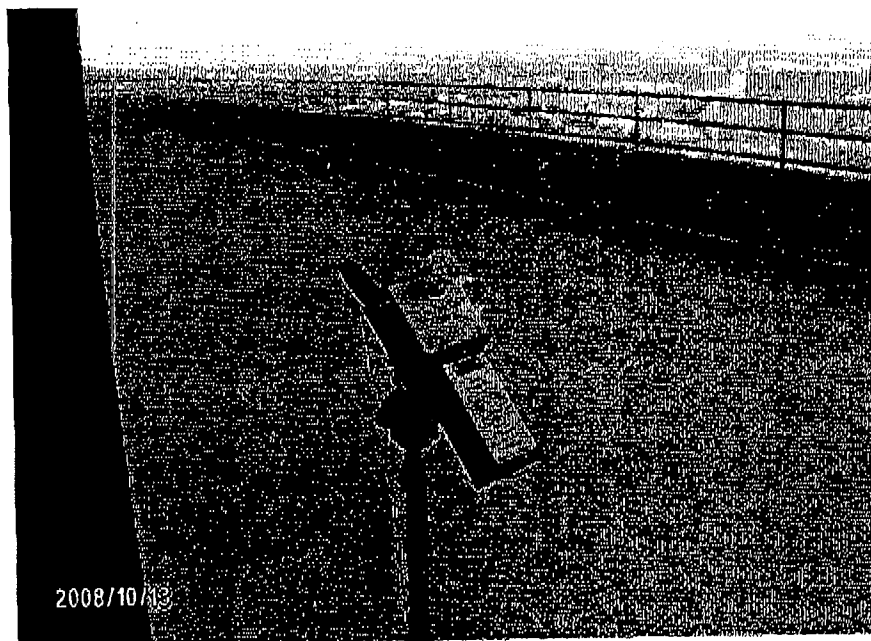
- 1) Image of ambient air sampling location at 23rd Floor western balcony of BOE building (Subject Building) located at 450 N Street, Sacramento.

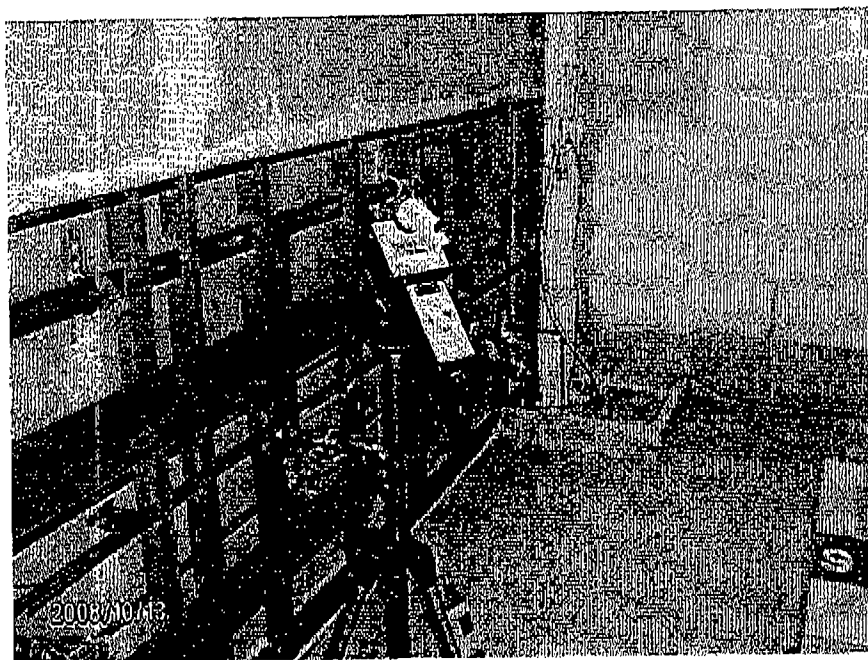
- 2) Image of air sampling equipment located within interior of Men's Restroom containment at time of assessment. Note sheetrock removal at area formerly containing sink cabinets.

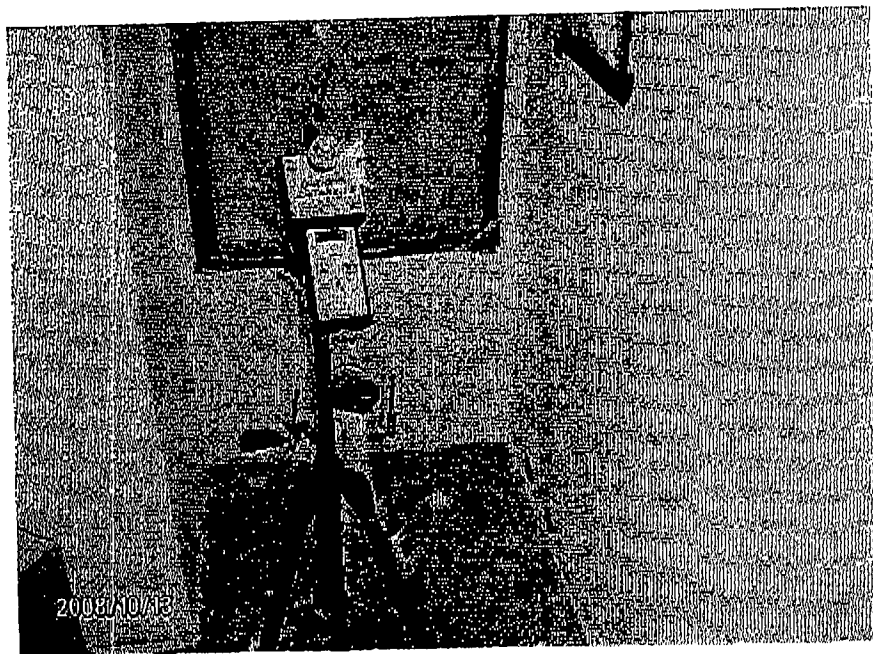
- 7) Image of air sampling equipment and repaired LCD inspection holes located within Janitor's closet room on south side of building.

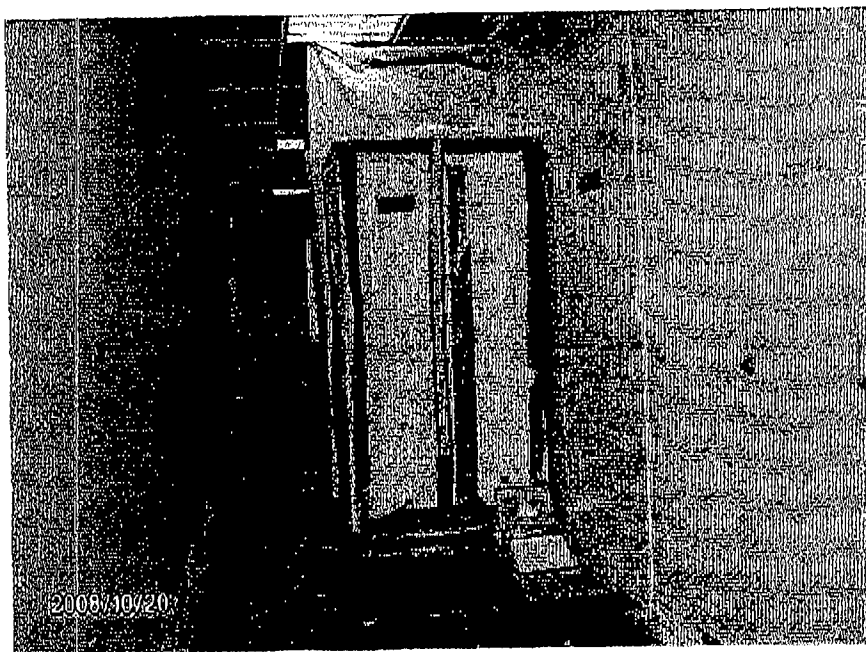
12) Image of hallway containment entrance and structures of LCD-C-7 at time of assessment.

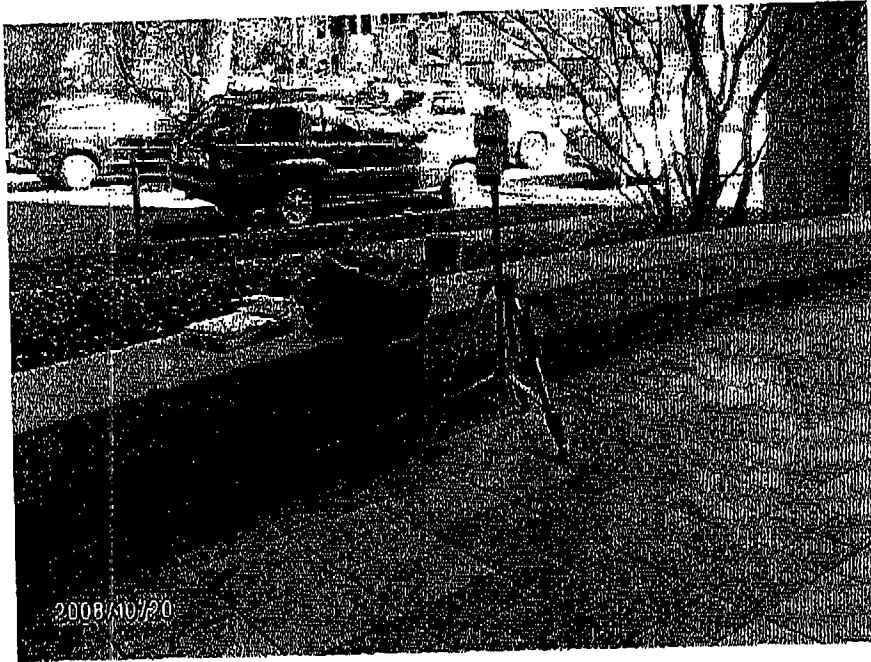
- 13) Image of ambient air sampling location at main entrance of BOE building performed at conclusion of interior clearance inspection sampling .
